TECHNICAL REPORT CERC-89-12

STABILITY OF ARTICULATED CONCRETE MATTRESSES FOR HERBERT HOOVER DIKE IMPROVEMENTS LAKE OKEECHOBEE, FLORIDA

Coastal Model Investigation

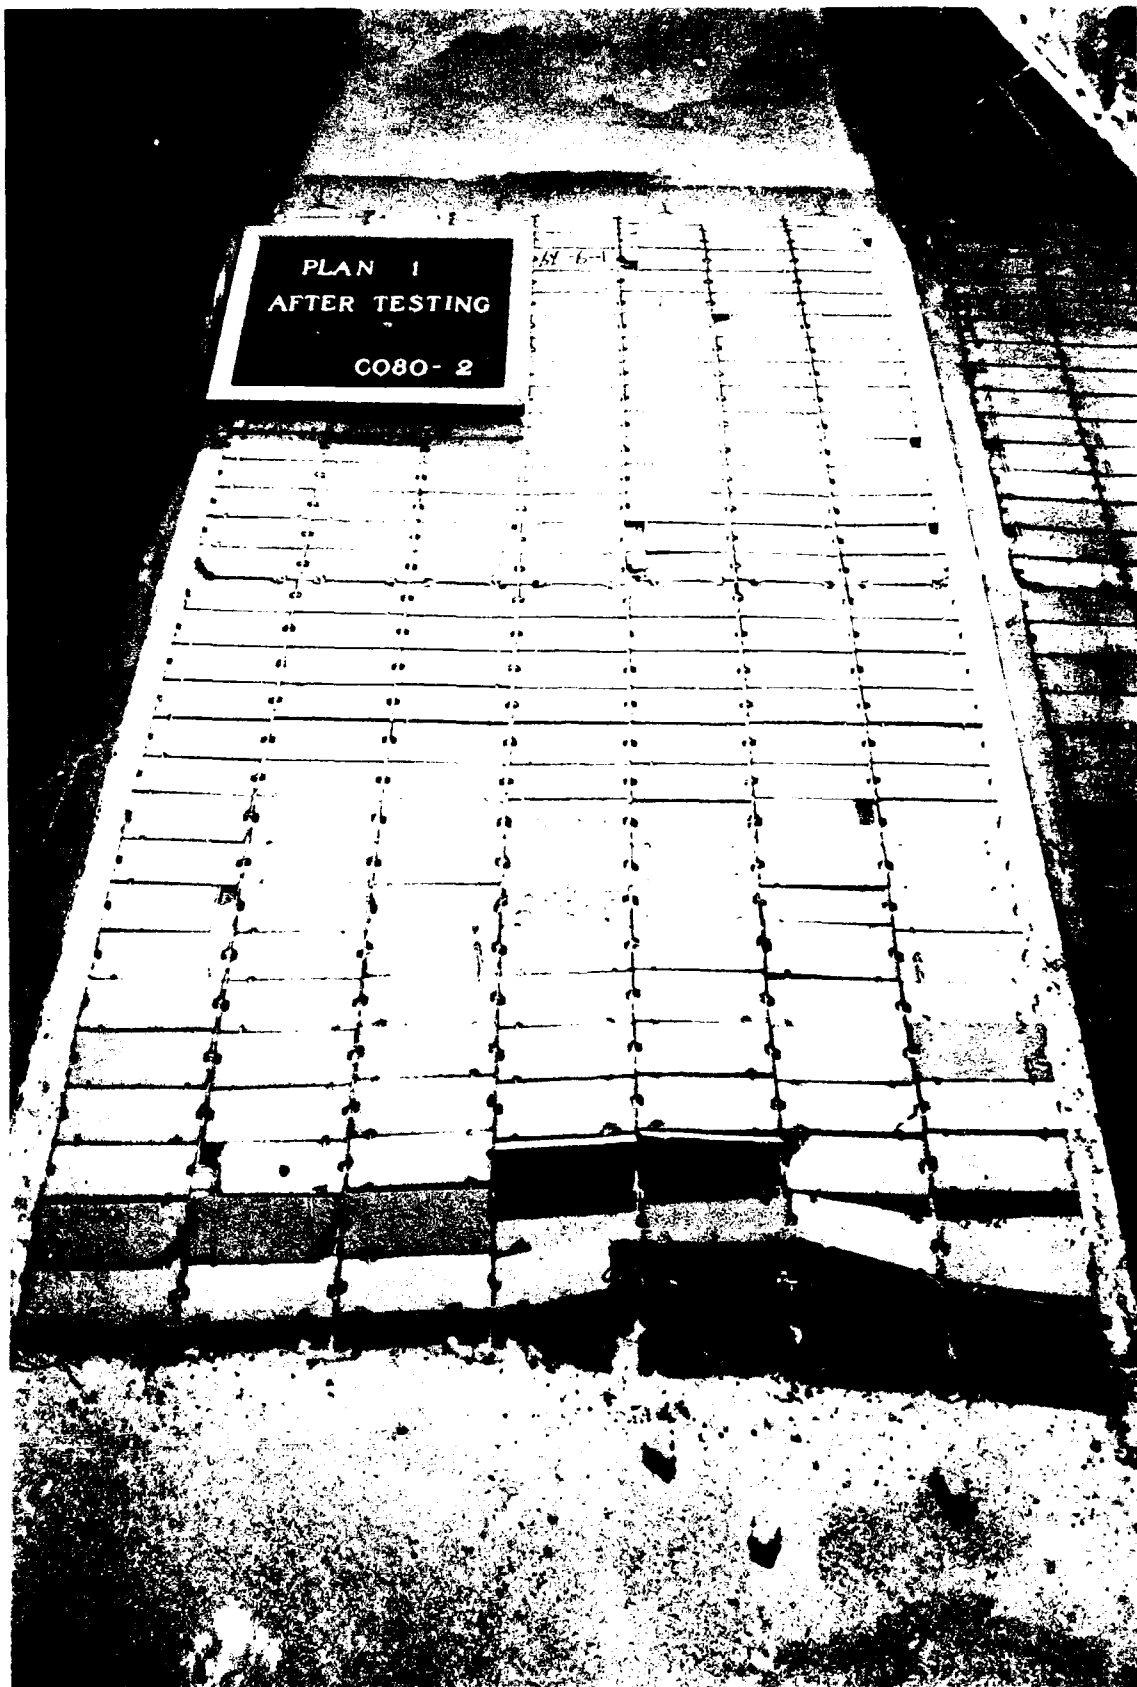
Photo 1. Side view of Plan 1 after wave attack

Photo 2. Sea-side view of Plan 1 after wave attack

13. Plan 1 consisted of a one-layer mat secured only by top anchors. This plan was stable for 2- and 3-ft waves; however, the 4-ft waves produced some lifting near the toe, and both the 5- and 6-ft waves caused the mat to roll upslope. Violent motions associated with the 5- and 6-ft waves caused some blocks near the toe to crack and/or break loose from the mat. Maximum observed runup was el +29. Runup values for all wave conditions investigated are presented in Table 1.

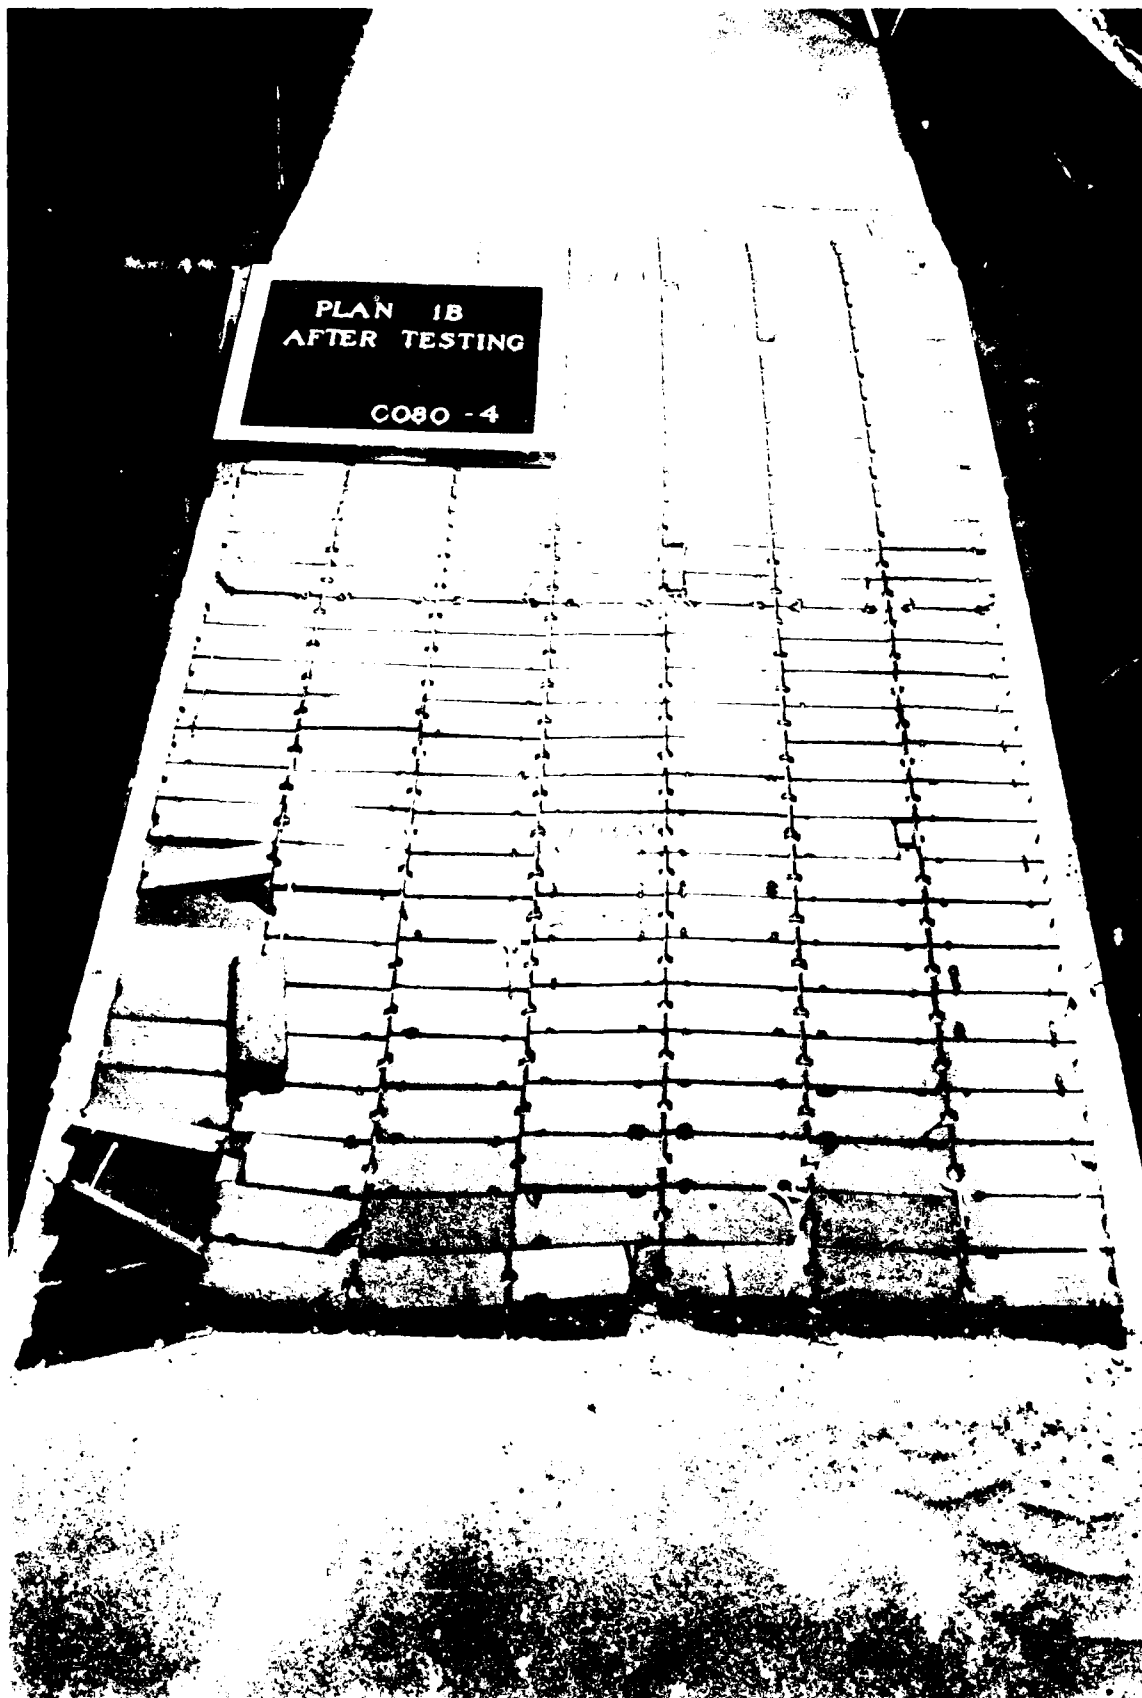
Photo 3. Side view of Plan 1B after wave attack

Photo 1. Sea-side view of Plan 1B after wave attack

15. Plan 1B was the same as Plan 1A except two rows of toe anchors were added. Stability improved slightly over previous plans; however, excessive lift still was observed in the unsecured area between the swl

and toe for 5- and 6-ft waves. Maximum observed runup was the same as the previous plans (+29).

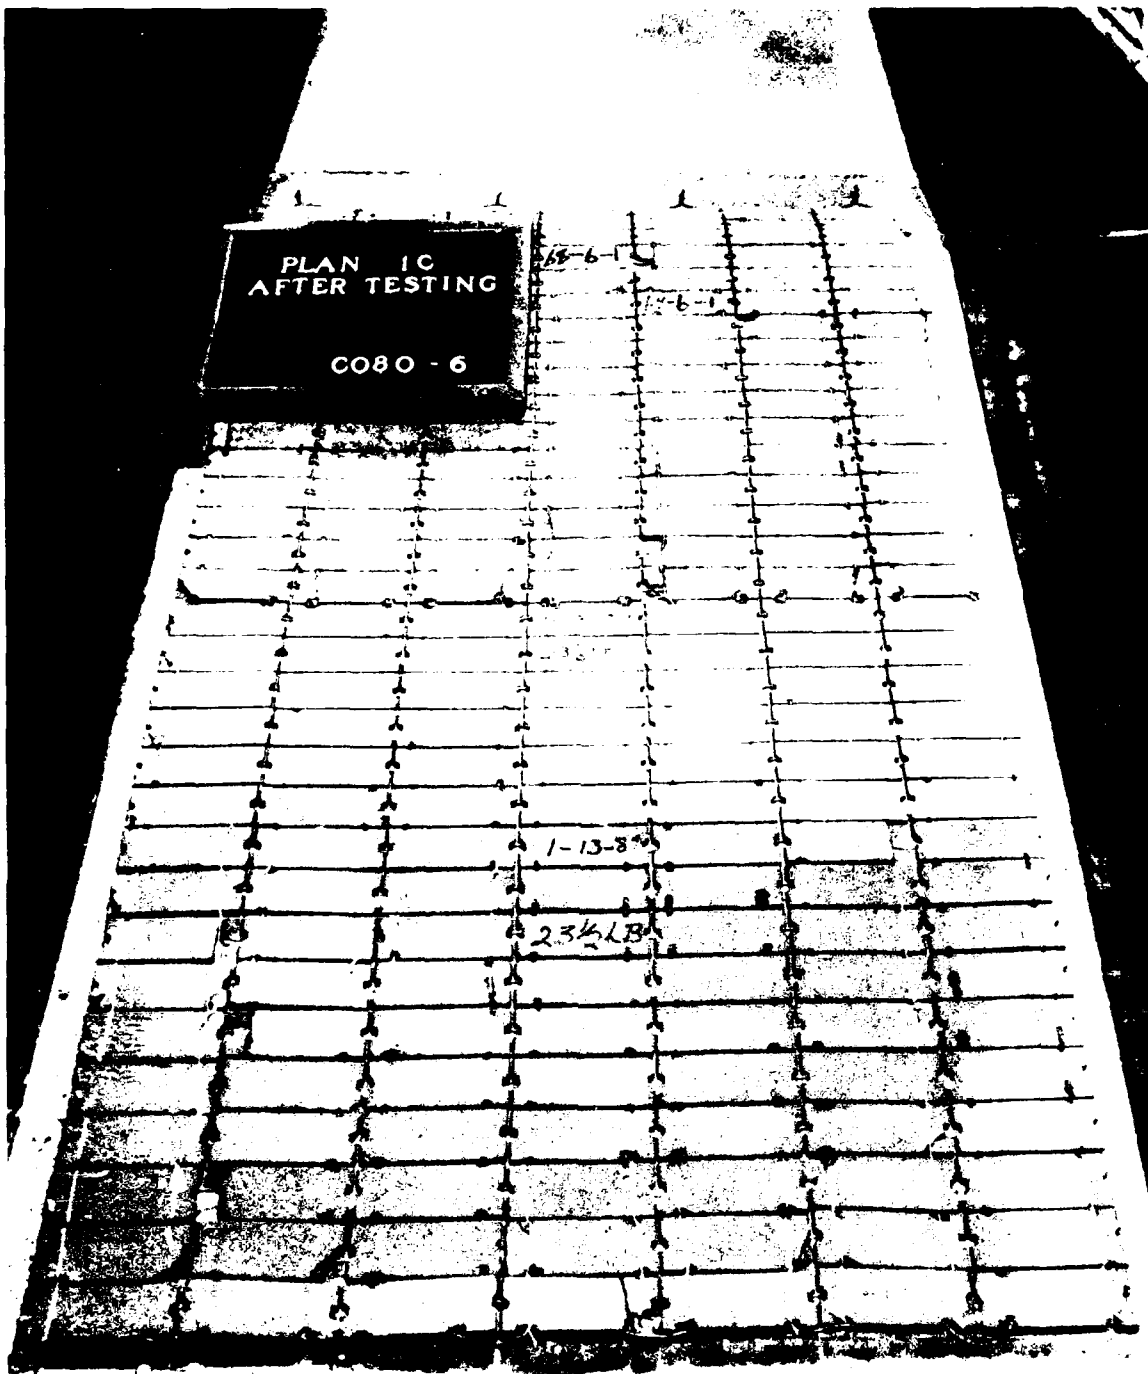
Photo 5. Side view of Plan 1C after wave attack

Photo 6. Sea-side view of Plan IC after wave attack

16. Plan 1C was similar to Plan 1B except additional anchors were added at alternate joints from the swl to the toe. As expected, this plan proved stable for all wave heights. Maximum runup was unchanged.

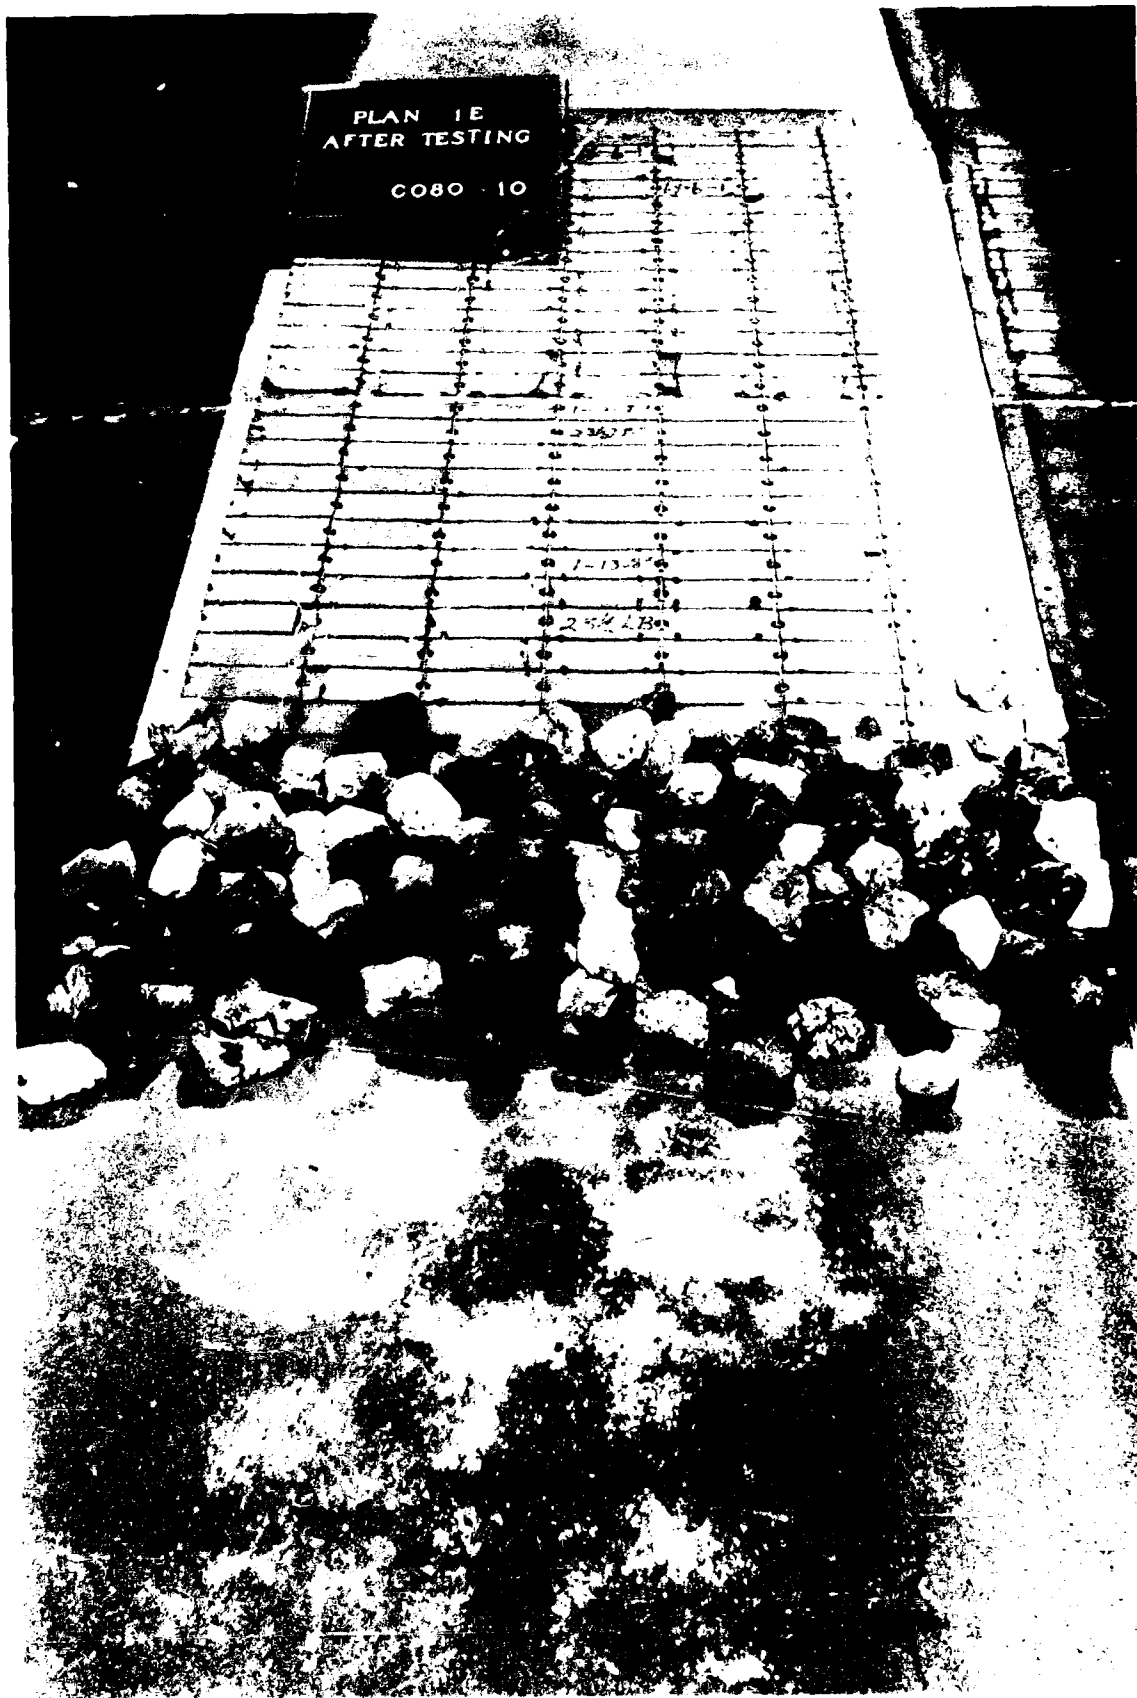
Photo 9. Side view of Plan 1E after wave attack

Photo 10. Sea-side view of Plan 1E after wave attack

18. Plan 1E was the same as Plan 1D except the toe stone weight was increased to 800 lb. Tests proved the plan to be stable for up to 4-ft waves; however, the 5- and 6-ft waves still caused excessive movement of toe stone upslope and downslope and produced significant lifting of the mat in the vicinity of the swl. Maximum runup was unchanged at +28.5.

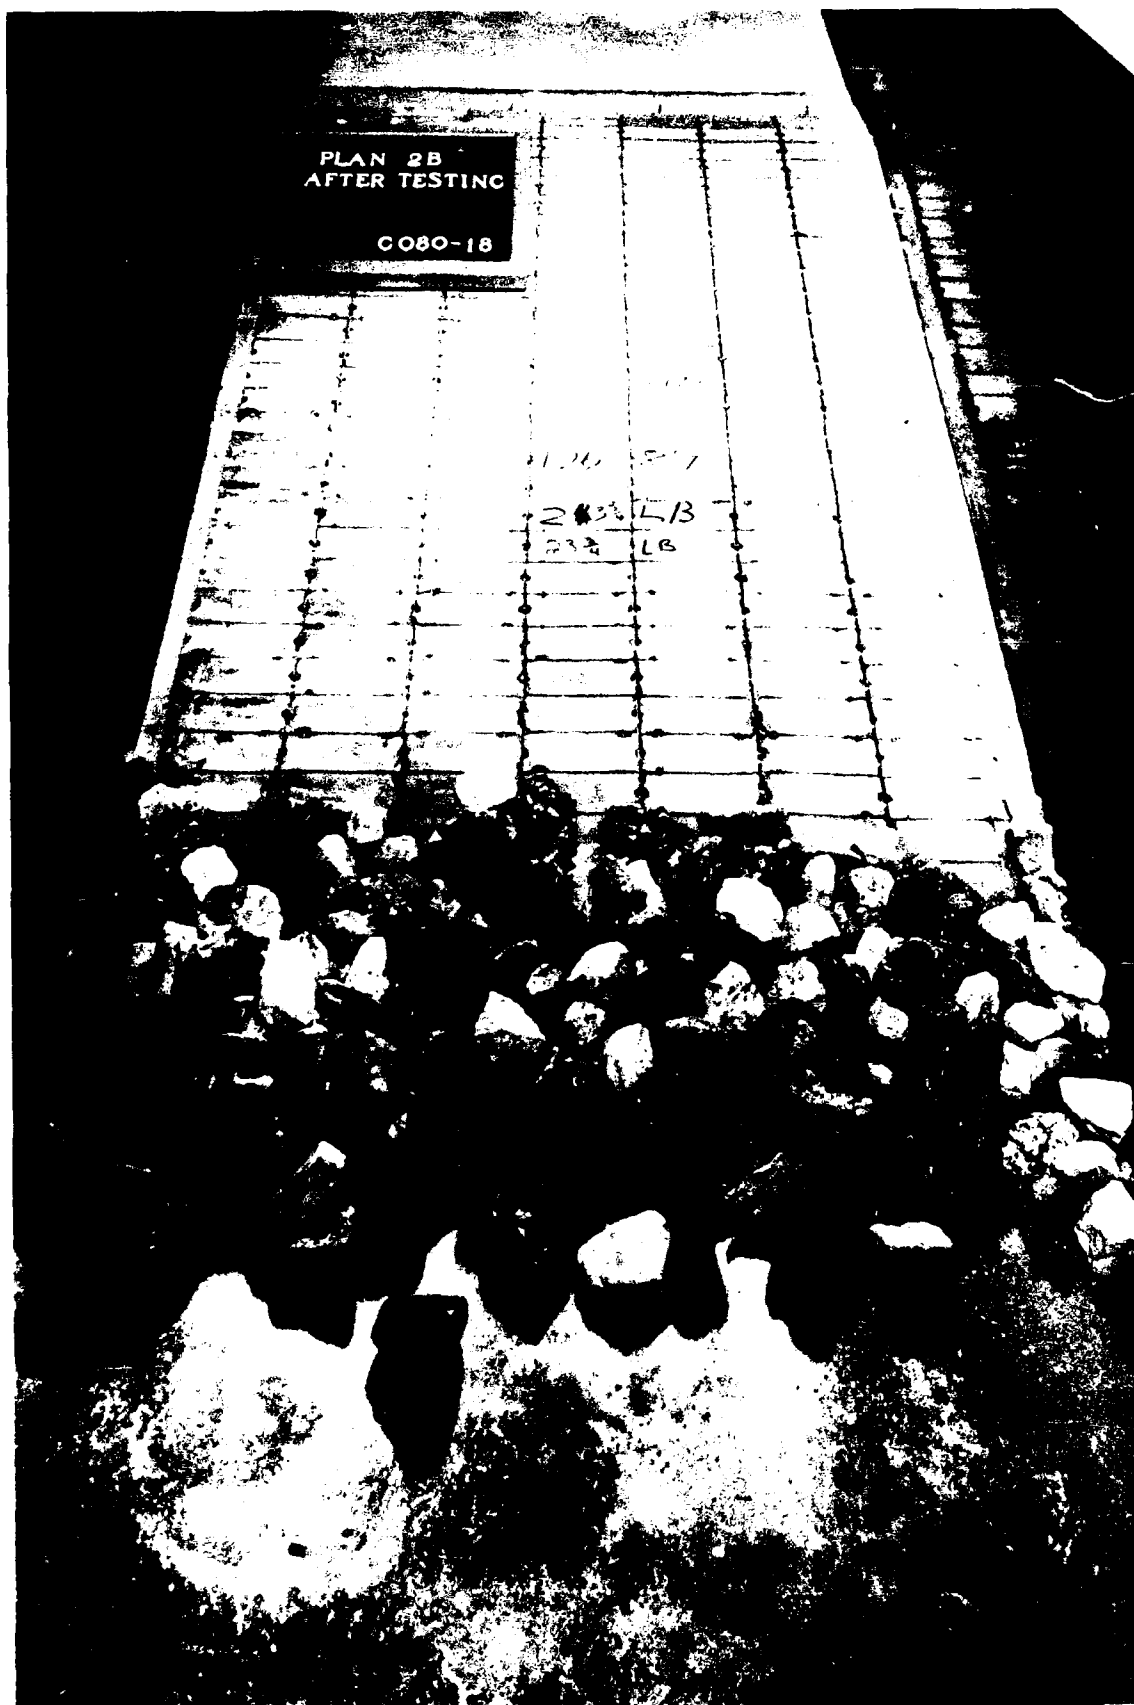
Photo 15. Side view of Plan 2B after wave attack

Photo 16. Sea-side view of Plan 2B after wave attack

21. Plan 2B was secured by top anchors and a 6-ft-wide, two-layer berm of 800-lb toe stone. This plan proved to be stable for 2-, 3-, and 4-ft waves; however, the 5- and 6-ft waves caused excessive movement of toe stone upslope and downslope. Very minor localized lifting of the mats in the

vicinity of the swl was observed during attack of the 5- and 6-ft waves. Maximum runup was reduced slightly to +28.5.

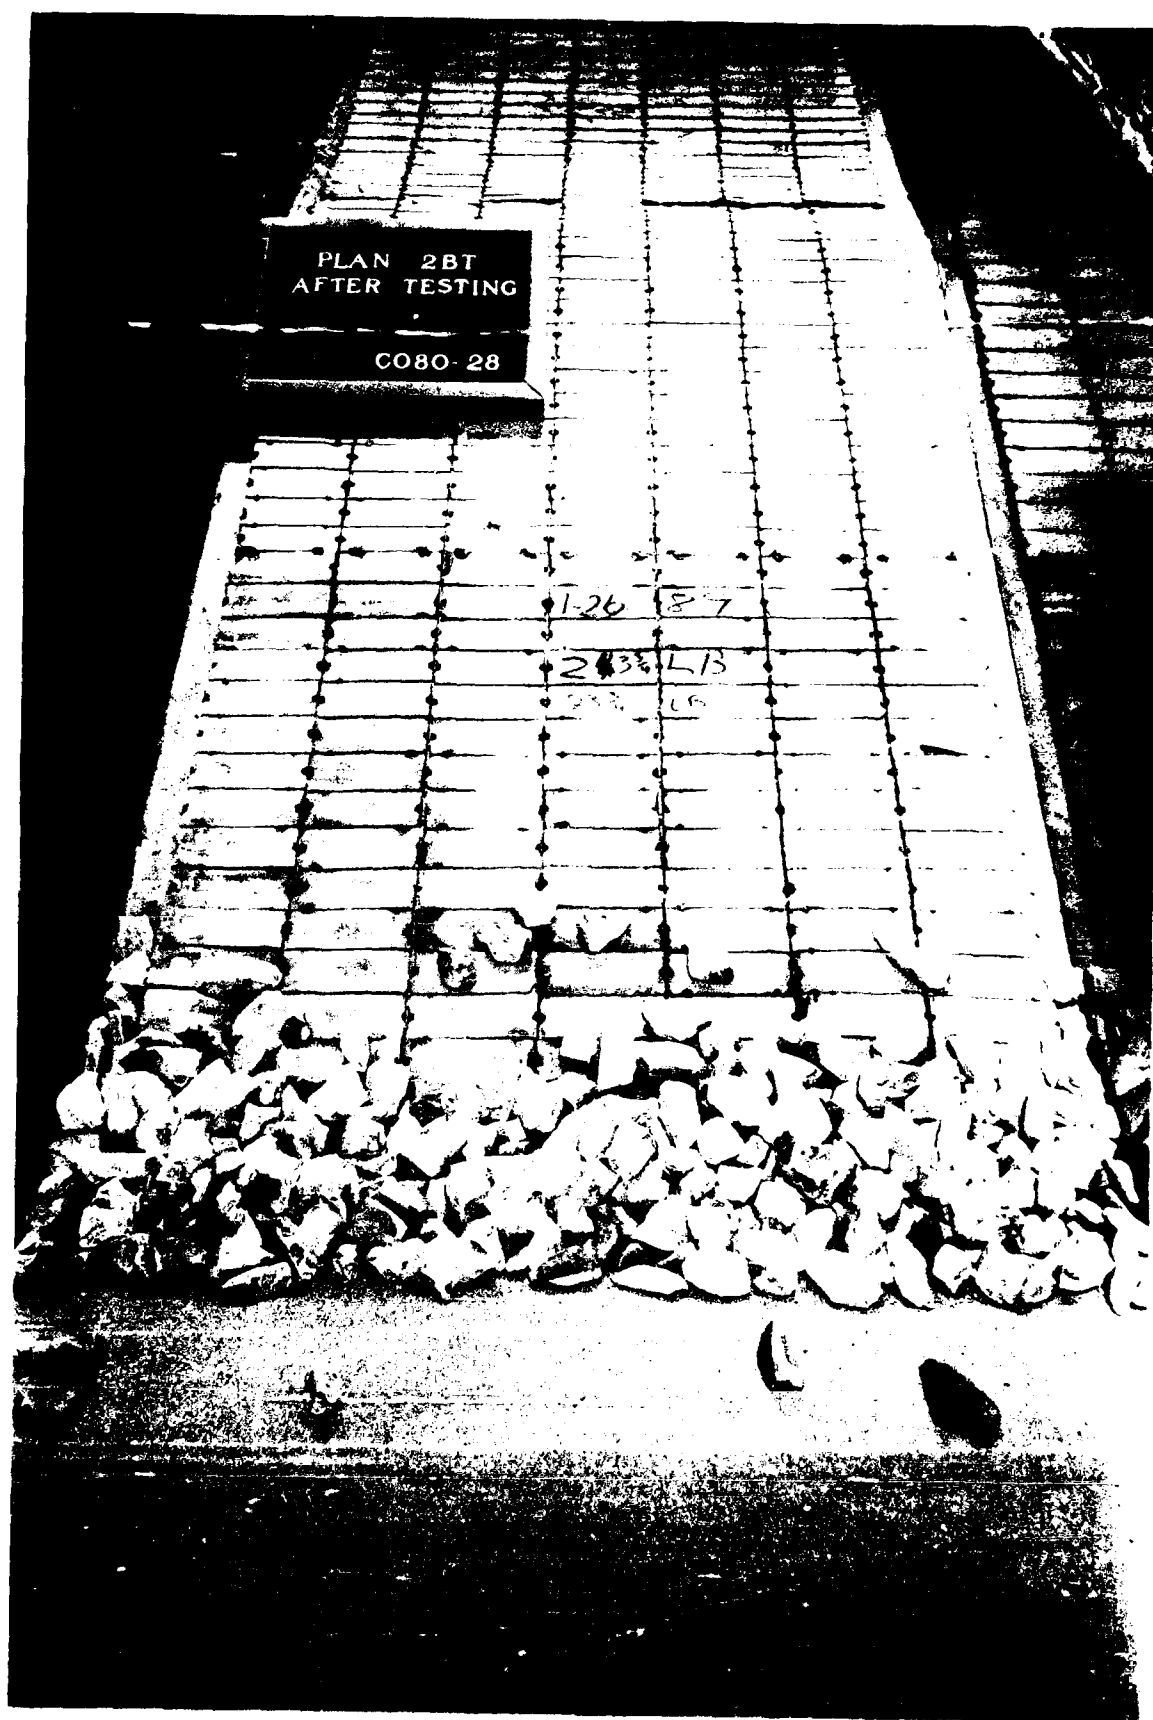
Photo 19. Side view of Plan 2BT before wave attack

Photo 20. Sea-side view of Plan 2BT before wave attack

Photo 21. Side view of Plan 2BT after wave attack

Photo 22. Sea-side view of Plan 2BT after wave attack

23. Plan 2BT was similar to Plan 2B except 500-lb toe stone was placed in a 3-ft-deep trench in an effort to improve stability. Also, a single mat was placed on the overbank above the existing two mats in an effort to reduce runup. Stability was achieved for 2-, 3-, and 4-ft waves; however, the 5- and 6-ft waves caused significant movement of toe stone upslope and downslope. The toe trench significantly improved stability in that the 500-lb stone exhibited a stability response similar to that observed for the 800-lb stone (tested in Plan 2B without a toe trench). Some localized lifting of the mats in the vicinity of the swl was observed during attack of the 5- and 6-ft waves. Maximum runup was reduced to +27.5.

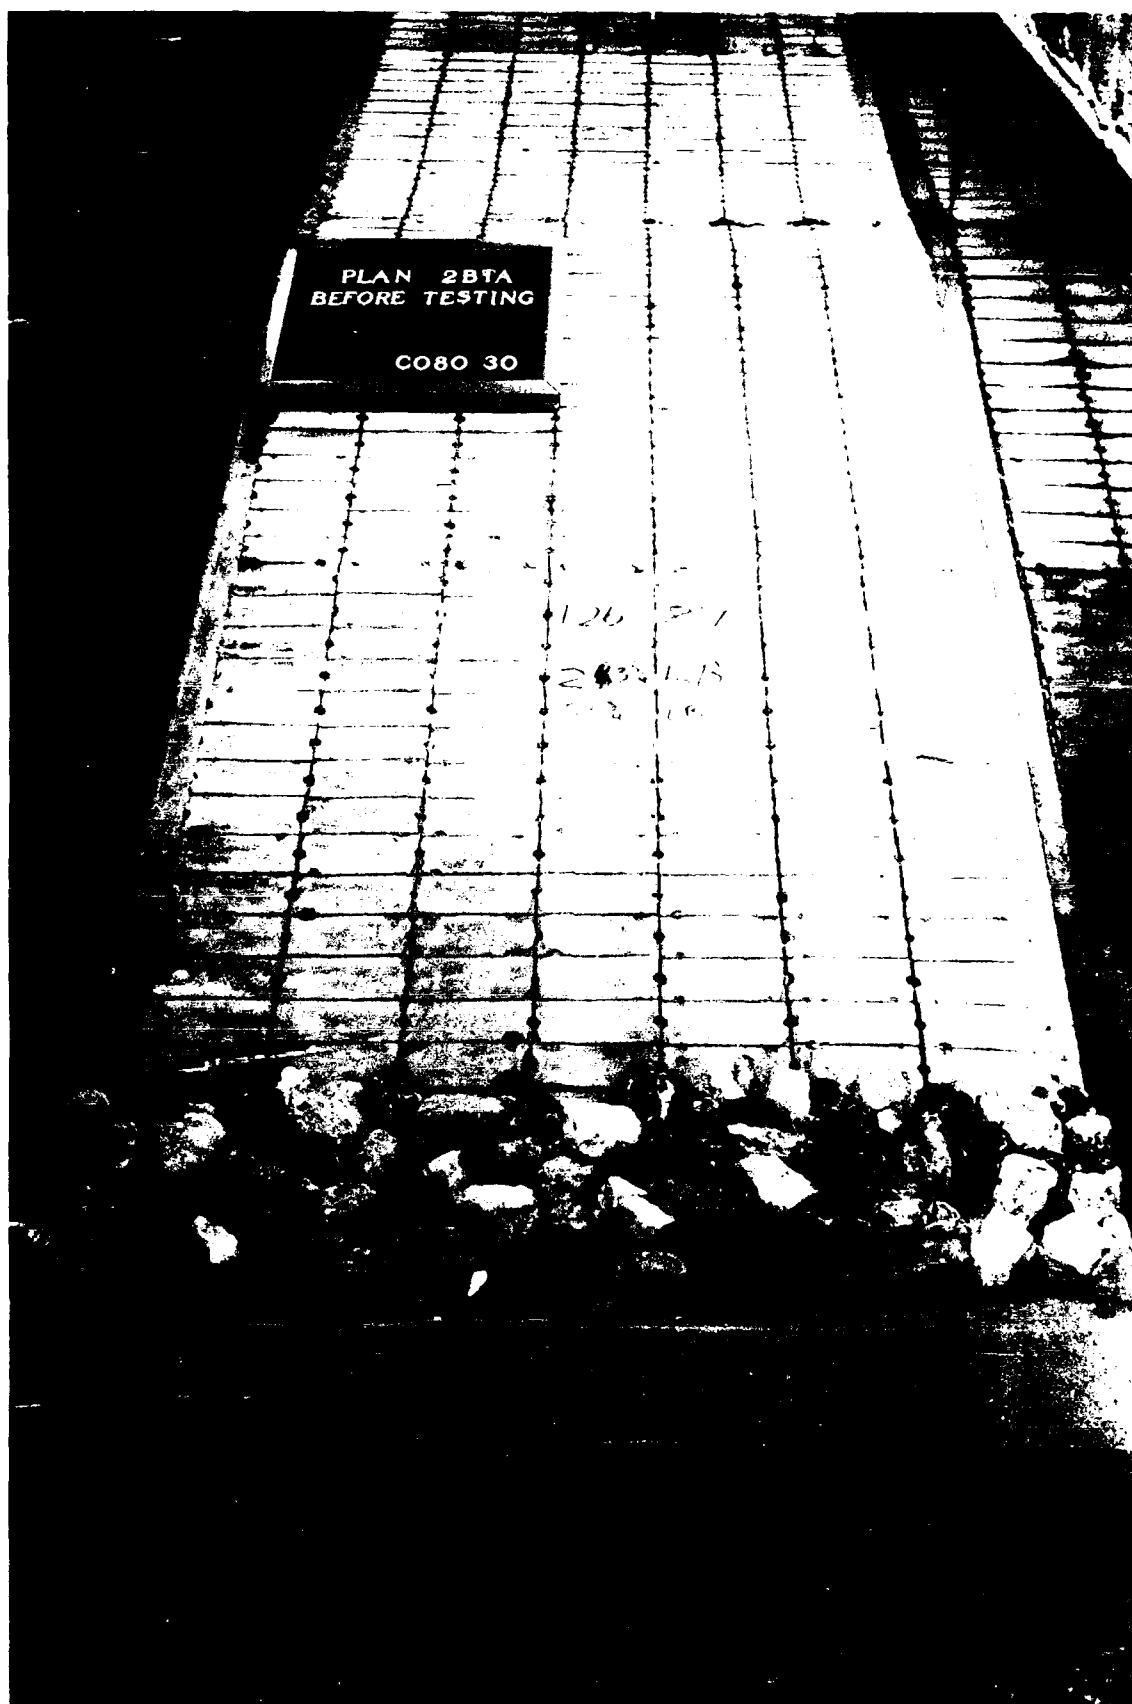
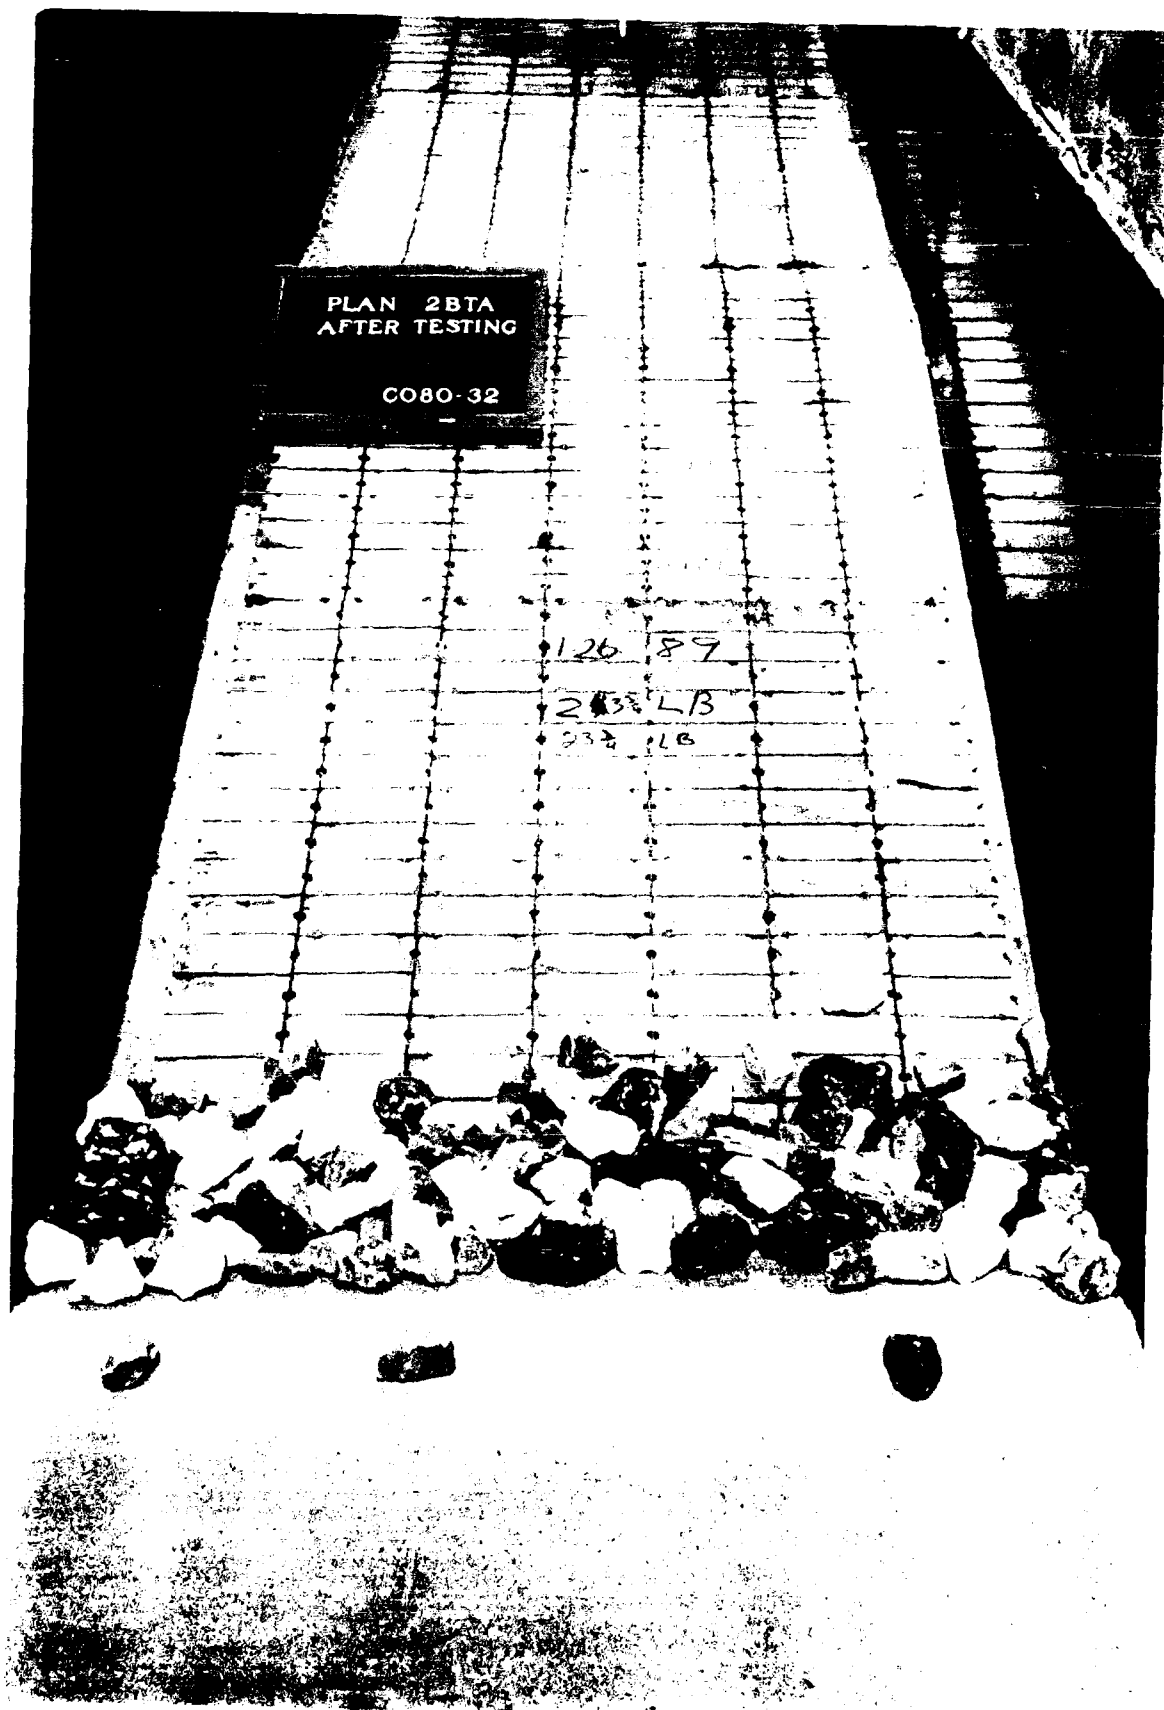
Photo 23. Side view of Plan 2BTA before wave attack

Photo 24. Sea-side view of Plan 2BTA before wave attack

Photo 25. Side view of Plan 2BTA after wave attack

Photo 26. Sea-side view of Plan 2BTA after wave attack

24. Plan 2BTA was the same as Plan 2BT except the toe stone weight was increased to 800 lb and three rows of anchors were added in the vicinity of the swl. As anticipated, toe-stone stability improved for the 5-ft waves; however, the 6-ft waves still caused significant movement of the toe stone upslope and downslope. Also, very minor localized lifting of the mats was observed between the areas secured by anchors and toe stone for the 5- and 6-ft waves. A check test at the +15.5 swl showed slightly greater stability than was observed at the +17.5 swl. Maximum observed runup was the same as Plan 2BT (+27.5).

28. During the course of testing, interest in the survivability (ability to withstand wave conditions in excess of the selected design conditions) of the two-layer plans arose. Plan 2BTA, one of the better alternatives tested, was exposed to 7-ft waves at an swl of +19.5 and movement of both the mats and toe stone was similar to that observed for the 6-ft waves.

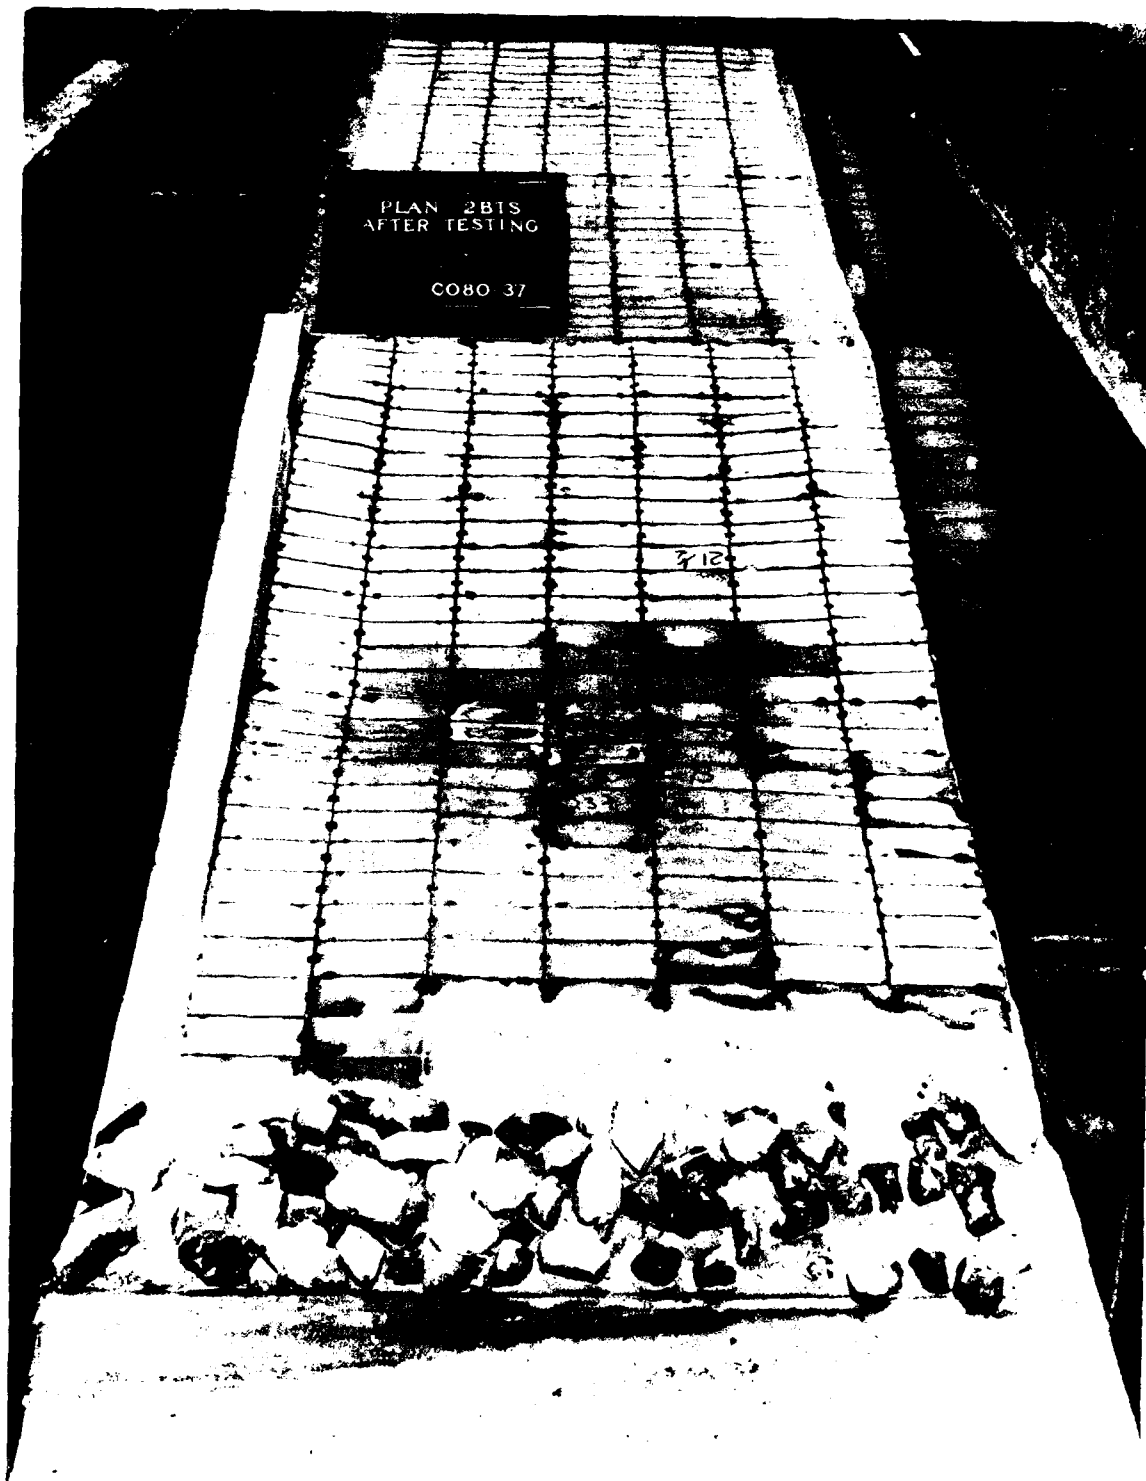
Photo 27. Side view of Plan 2BTS before wave attack

Photo 28. Sea-side view of Plan 2BTS before wave attack

Photo 29. Side view of Plan 2BTS after wave attack

Photo 30. Sea-side view of Plan 2BTS after wave attack

25. Plan 2BTS was the same as Plan 2BT except the toe-stone weight was 800 lb and the mats were placed over a 2.5-ft-thick layer of sand in an effort to obtain a qualitative indication of sand movement. Attack of the 2-ft waves caused about half of the sand layer to erode between the swl and +21. The 3-ft waves removed the sand layer between the swl and +22. Attack of 4-ft

waves produced complete removal of sand above the swl as evidenced in Photos 27 and 28.
